# STRUCTURAL CONDITION INSPECTION REPORT

St. Philips Church  
Town of Portugal Cove- St. Philips, NL.

Issue Date:	Status:	Project #:	Issued By:	Checked By:	Approved By:
Dec 23 , 2011	R0 - Issued for Review	2011-347	RT	SS	RT
January 16, 2012	R1 - Issued to Client	2011-347	RT	SS	RT

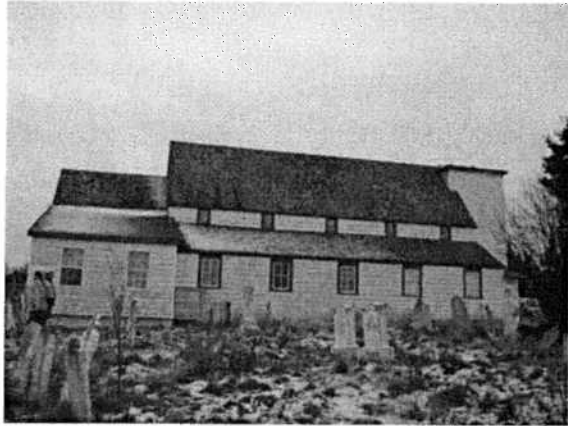
Church side view with main entrance and steeple (front).
1.2

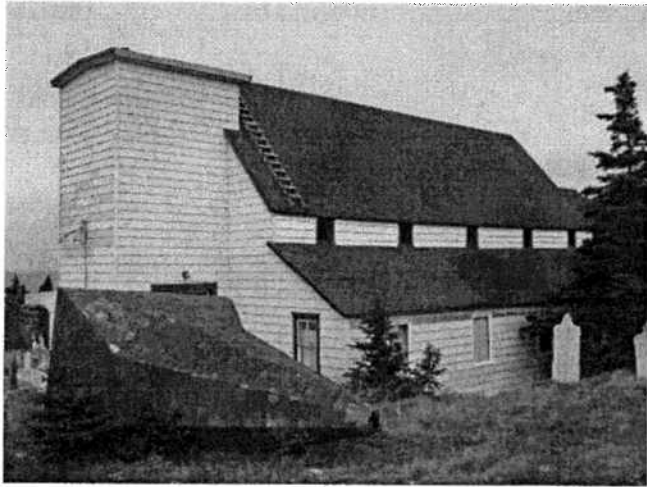
Church front view with main entrance and toppled steeple.
1.3

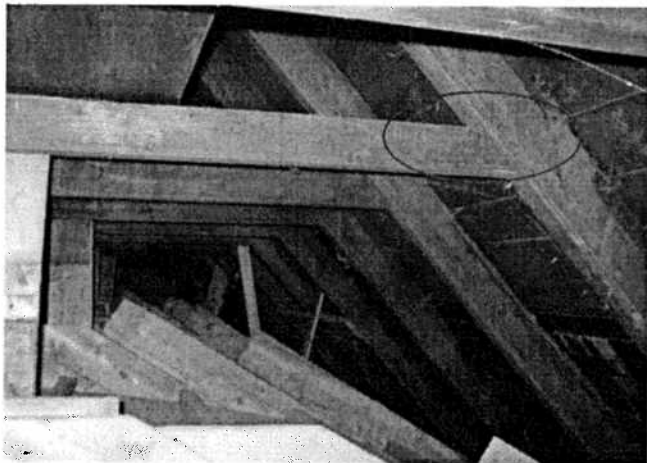
Roof rafter system with horizontal ties. Taken in attic space.

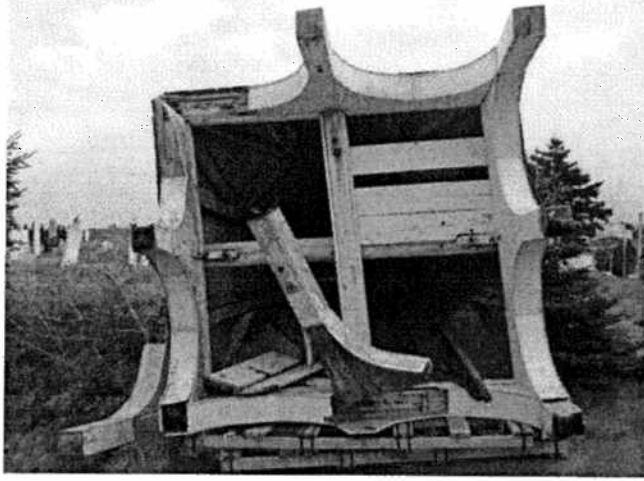
<p>1.4</p>

<p>Topped steeple showing support and framing system.</p>
------------	--	---

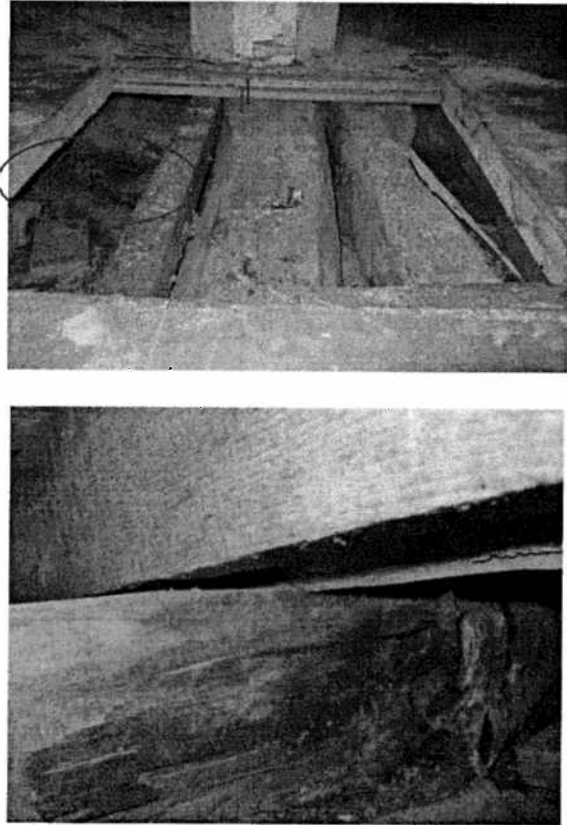
<p>Interior column support showing transverse raft framing and longitudinal framing below (circled). Longitudinal member is rotting at ground interface.</p> <p>This deficiency if not addressed over time could become a significant structural concern.</p> <p><b>High Priority Deficiency</b></p>

The Church's original interior raft foundation has settled slightly due to dry-rot at the ground interface and will rot and deflect more with time resulting in further settlement and perhaps differential settlement. We consider this a high priority condition issue that needs to be addressed through repairs if the building is to be occupied.

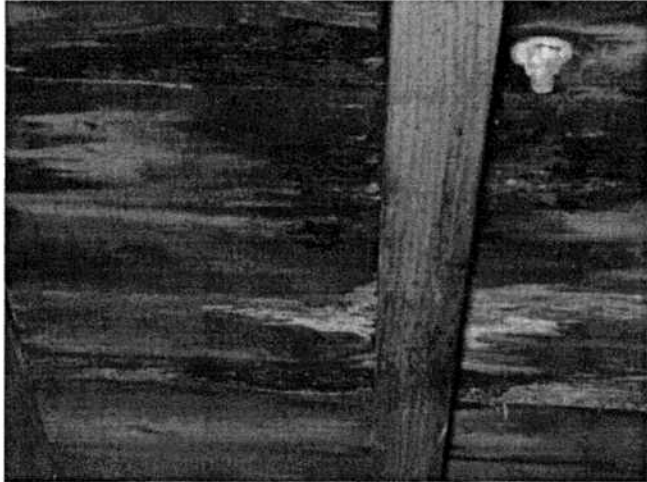
<p>Rot in steeple section framing. This is due to water infiltration compounded by lack of heat and electricity.</p> <p><b>High Priority Deficiency</b></p>
2.3

Several areas of the steeple support system, the steeple itself and the rear extension are showing signs of rot due to water penetration. This penetration is due to breakdown in the roofing system because of no maintenance and compounded further by no heat in the building. These areas are considered high priority and should be repaired before they become significant structural condition items.

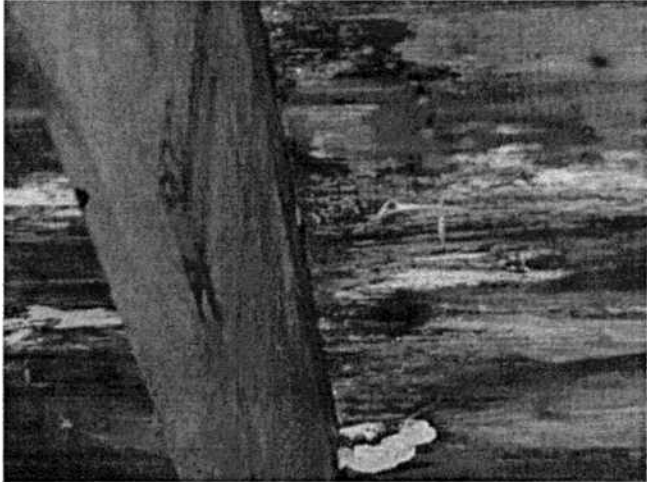
<p>Rot in steeple section framing. This is due to water infiltration compounded by lack of heat and electricity.</p> <p><b>High Priority Deficiency</b></p>

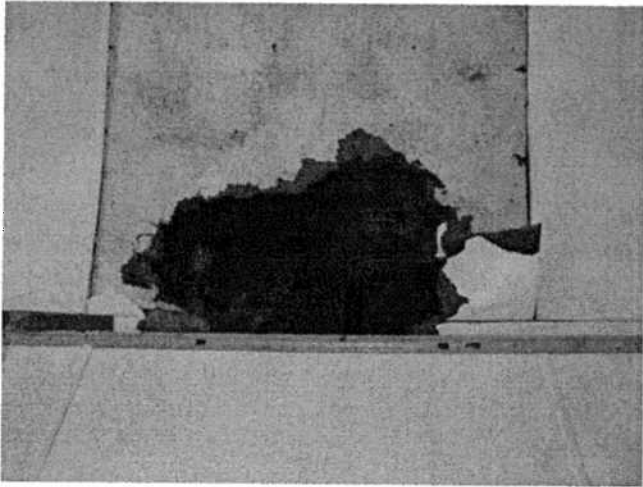
<p>2.4</p>

<p>Signs of water penetration in rear section of church at roof wall interface. This is due to water infiltration compounded by lack of heat and electricity. <b>High Priority Deficiency</b></p>
<p>2.5</p>

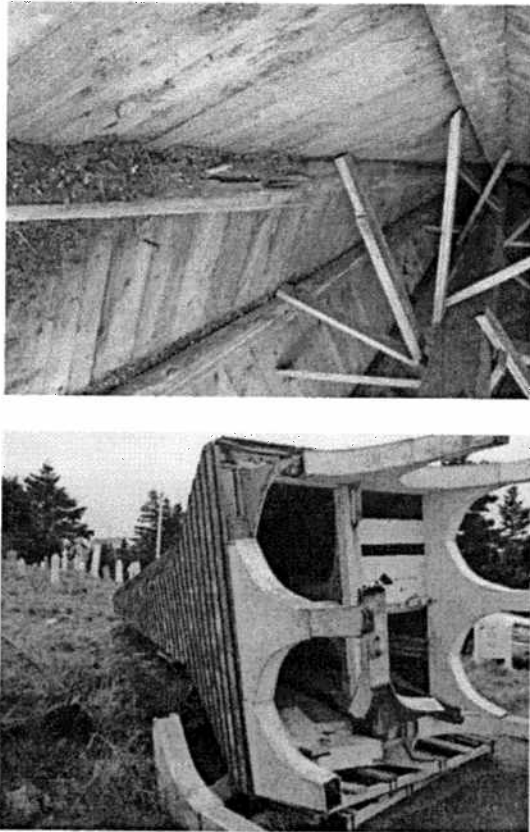
<p>Rotted sections of steeple section plus damage broken leg on steeple section <b>High Priority Deficiency</b></p>
